## **RAILWAY INVESTIGATION REPORT**

**R99T0017**

### **TRAIN PASSED A SIGNAL INDICATING STOP**

**VIA RAIL CANADA INC.**

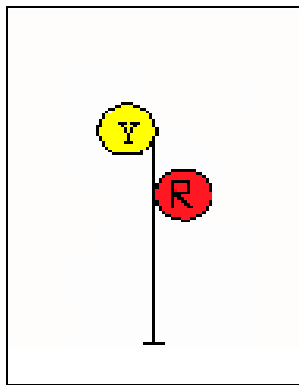
**Figure 6.** Signal 2352S indicating clear to stop

As explained in 1.12.2.2, signal 2352S was functioning as intended and displayed a clear to stop indication as VIA 52 passed it. The three crew members met vision and colour perception requirements and would have identified the signal aspect, had it been observed.
